TECHNICAL PUBLICATION # 79-2

June 1979

IMPROVEMENT OF THE CANAL-AQUIFER
FLOW REGIME IN THE C-1N BASIN

Resource Planning Department
South Florida Water Management District
West Palm Beach, Florida 33402

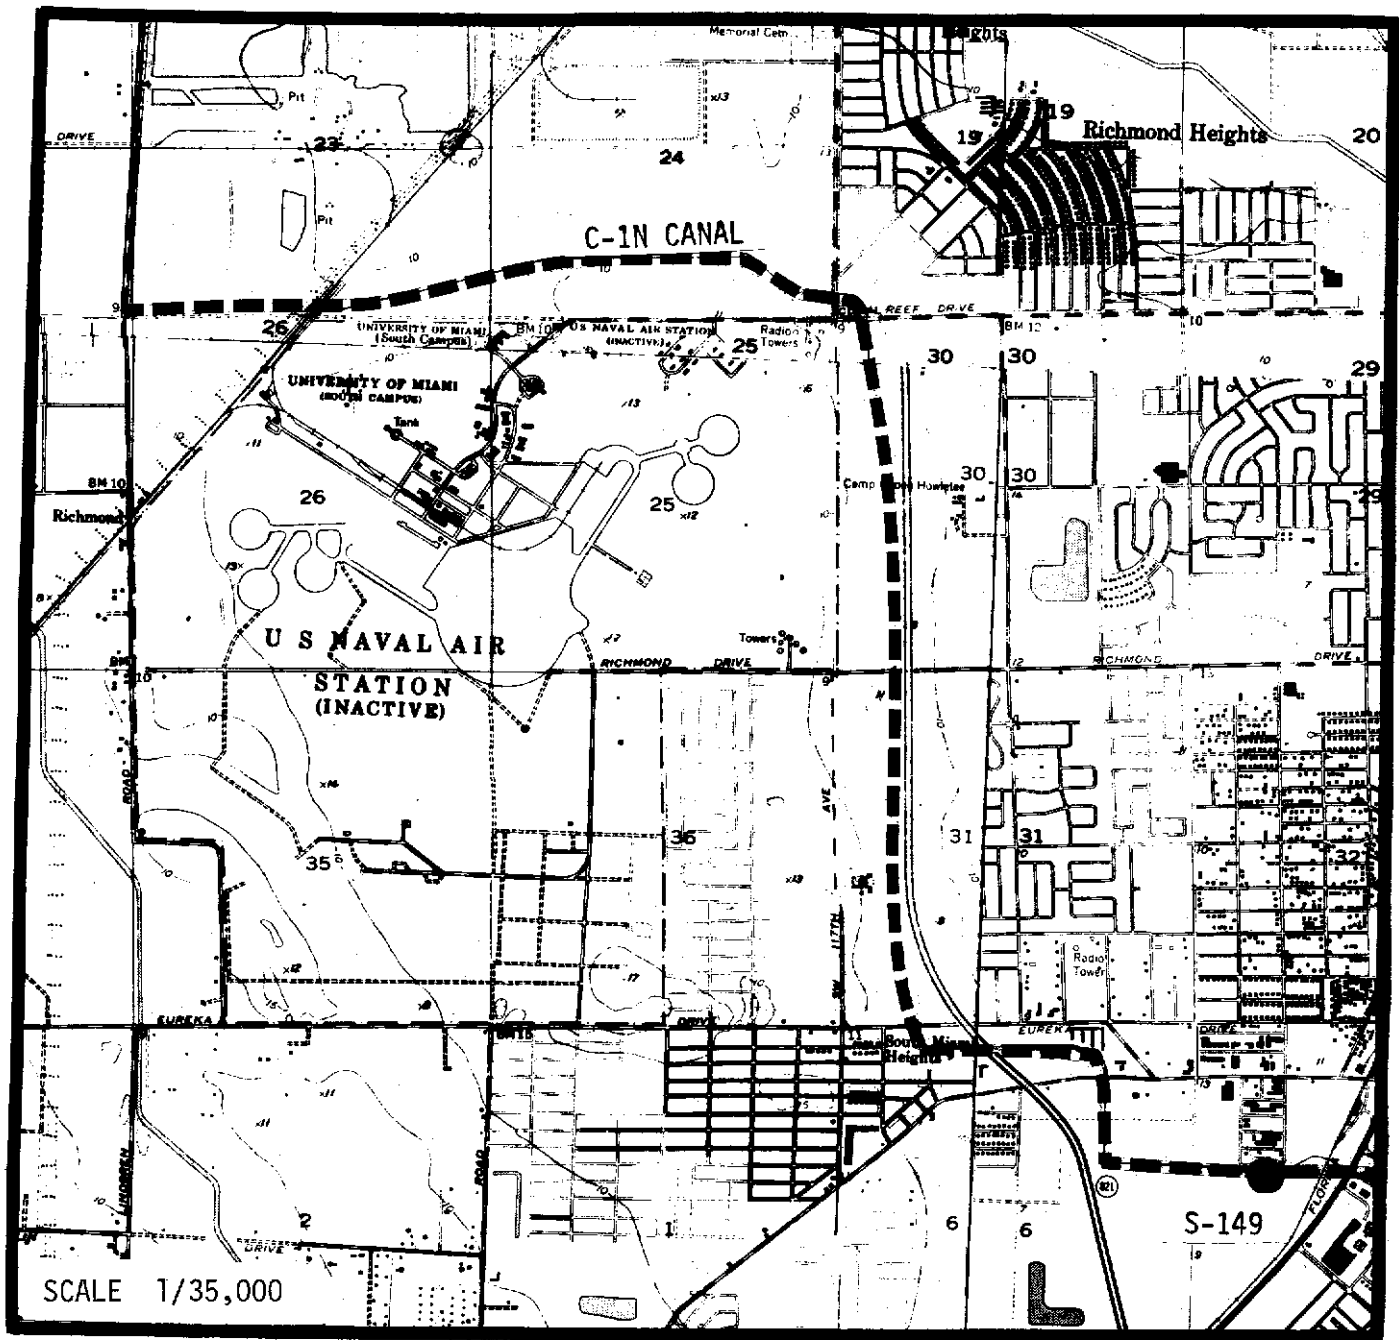
Figure 2. Map showing C-1N, S-149, and adjacent features.

The designs of canals C-1, C-1N, and structures S-148, S-149 and S-21, are described in three volumes (Corps of Engineers, 1959, 1960 and 1962). Maps showing the locations of these canals and structures and the physical features of the C-1N basin are presented in Figures 1 and 2. The design functions of the system are as follows (from Corps of Engineers, 1962):

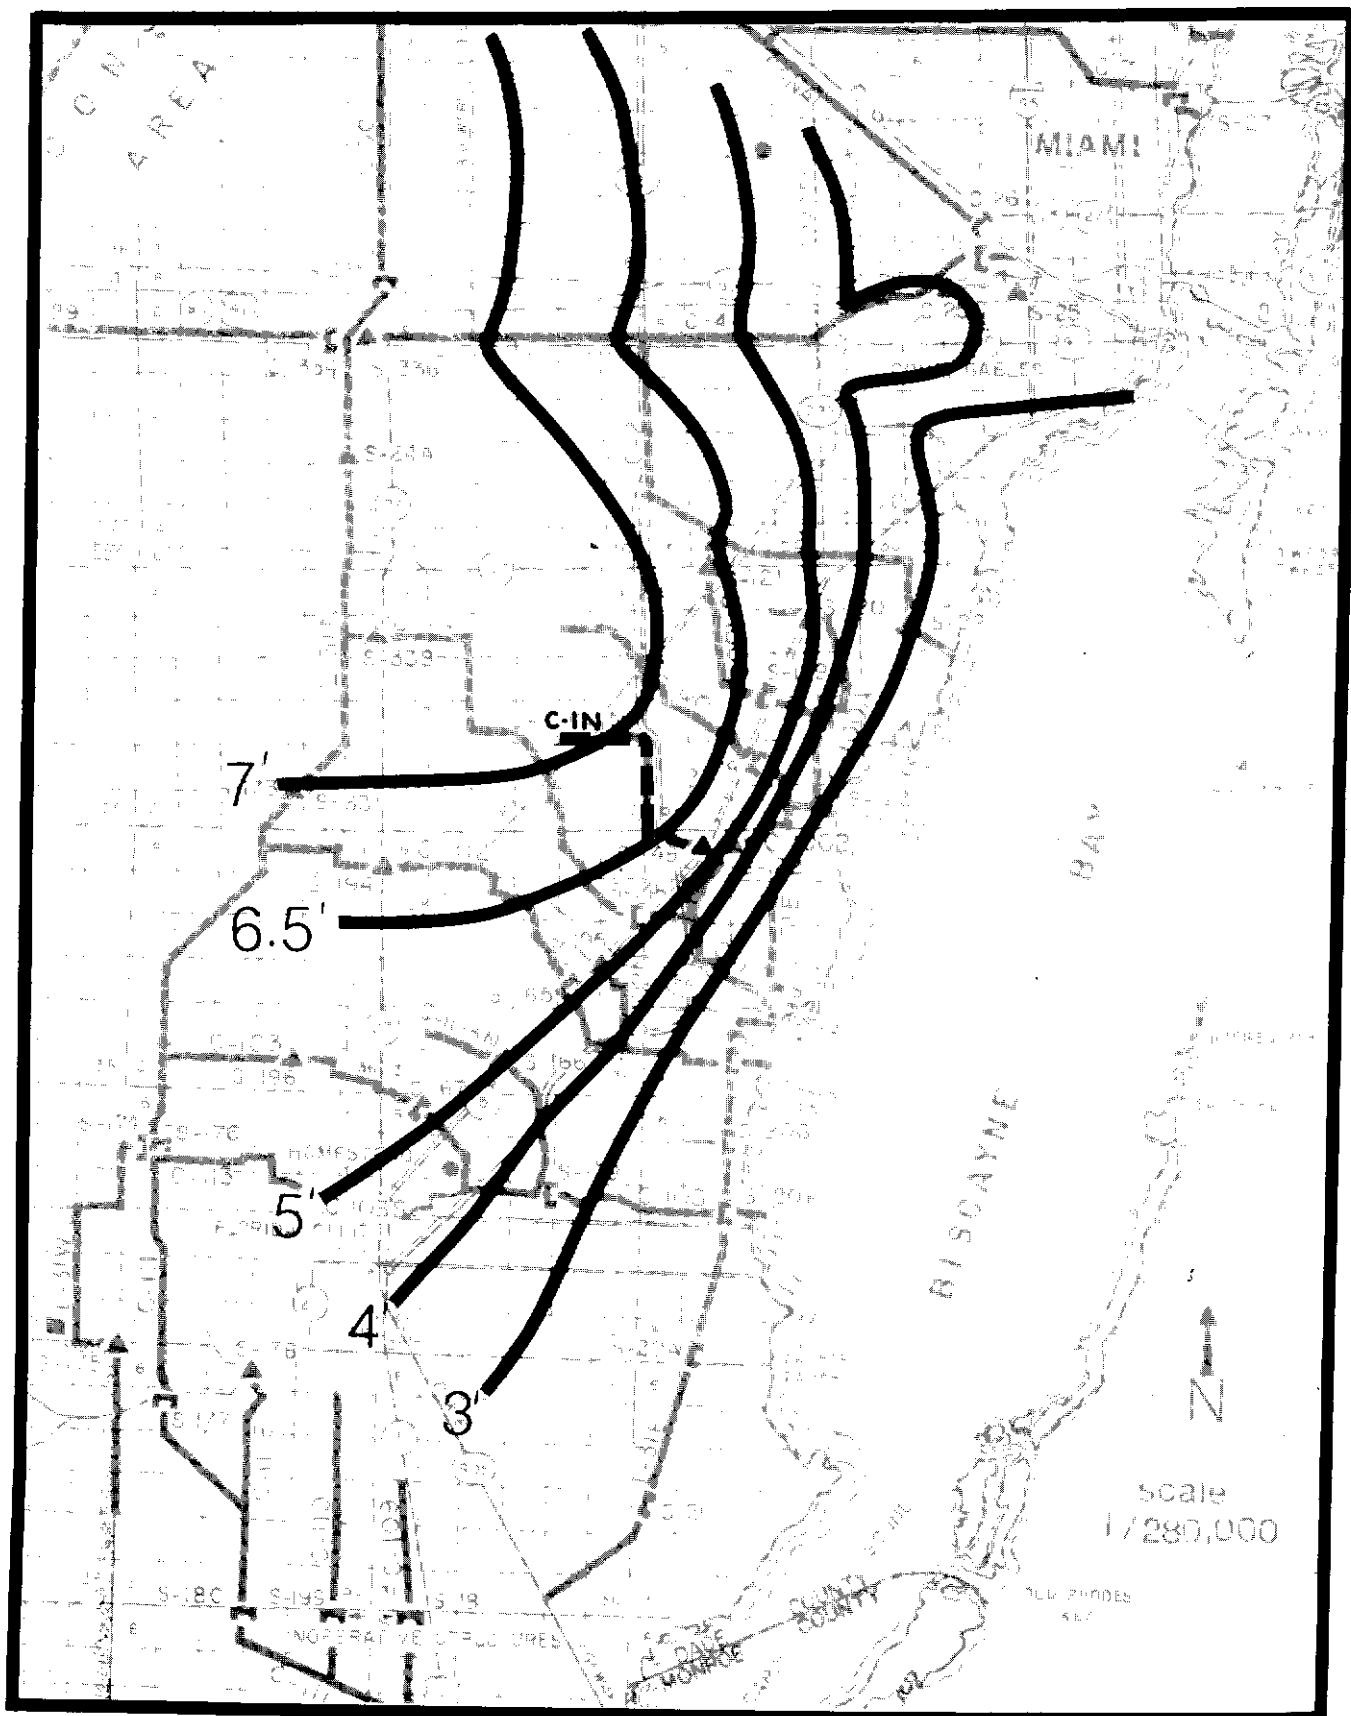
Figure 3. Contours of average October groundwater levels from 1940 to 1957 (from U. S. Geological Survey, unpublished map).

According to the Corps of Engineers' evaluation only 2.14 inches of the 12.20 inches of rainfall infiltrates to the aquifer. If the aquifer is assumed to have a specific yield of 0.20, this would mean that the antecedent groundwater level was considered to be about one foot below ground surface. As evidenced from a U. S. Geological Survey contour map (Figure 3) showing average October

(maximum annual water table stages usually occur during October) groundwater levels for the period 1940-1957 (prior to Project construction and resultant drainage effects), the storage available would have been about 2.5 feet, which is equivalent to six inches of free water. Although more water was routed to ET than to infiltration, their sum (5.87 inches) is approximately equal to the actual ground storage available. Thus, the runoff estimate, although erroneously calculated, is quite close to that expected considering the predrainage groundwater levels.

Water table contour maps in this area indicate that groundwater flows in a direction slightly south of east (Figures 3 and 4). In the north-south oriented reach of C-1N upstream from Eureka Drive, when the canal stage ranges from 2.5 to 3.0 ft. msl, the discharge profile shows a flattening tendency. This tendency is due to the orientation of the canal and groundwater contour lines, as the contour lines intersect the canal at a very slight angle. This situation results in minimal exchange of water between the canal and aquifer, because of the small head differences between the canal and the water table.

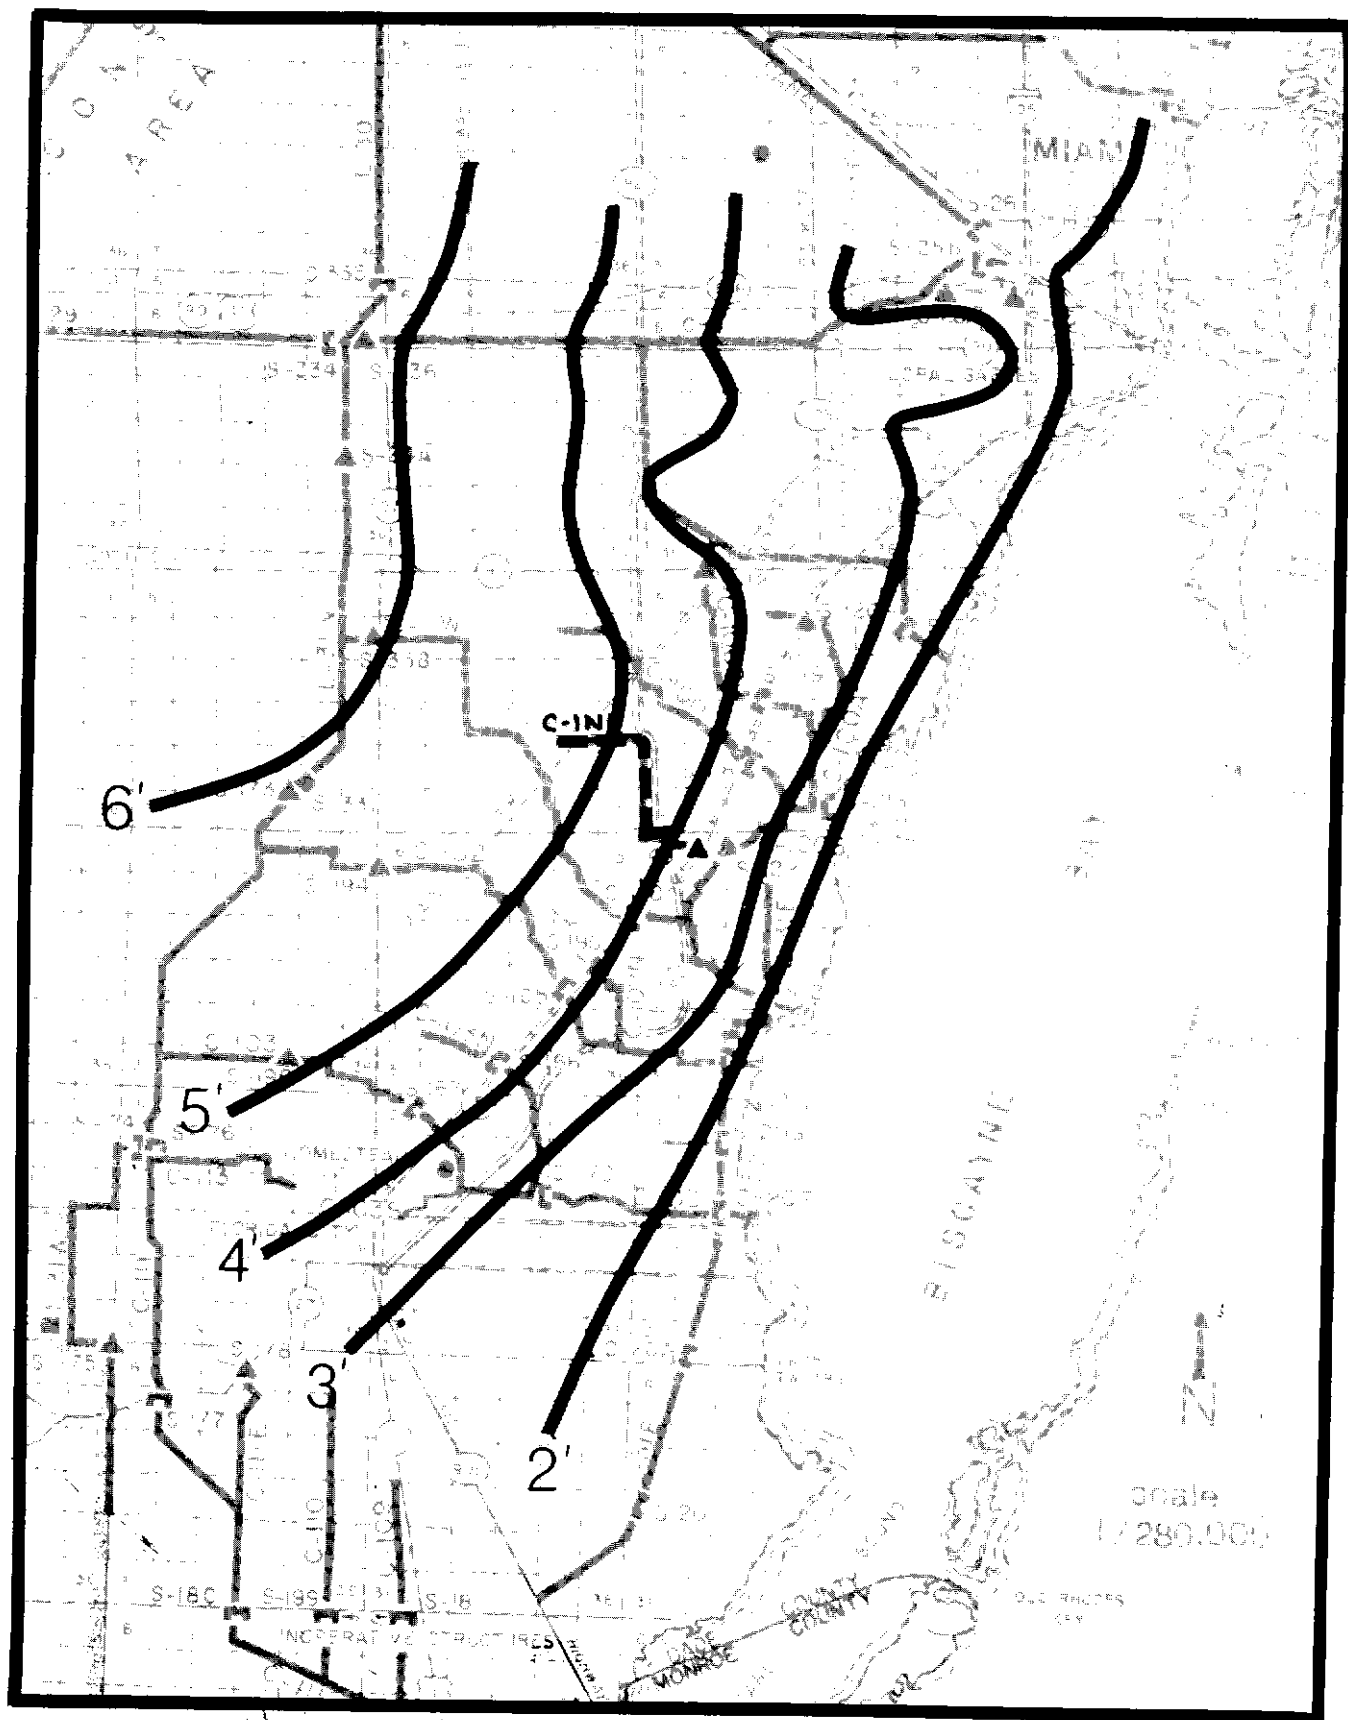
Figure 4. Contours of average October groundwater levels 1960 to 1975 (U. S. Geological Survey, 1977).

The reason for the lack of surface water drainage is apparent when average October groundwater levels for the period 1960-1975 are considered (Figure 4). A mean October groundwater elevation of about 4.5 feet msl is indicated. This

mean value is somewhat higher than the post-Project mean, because C-1N and S-149 were completed in mid-1963. The land surface elevation is fairly consistent at about 10.0 feet msl. Assuming an aquifer storage coefficient of 0.2, the entire amount of rainfall representing the 10-year event could be accommodated in aquifer storage. The storm routing would be approximately as follows:

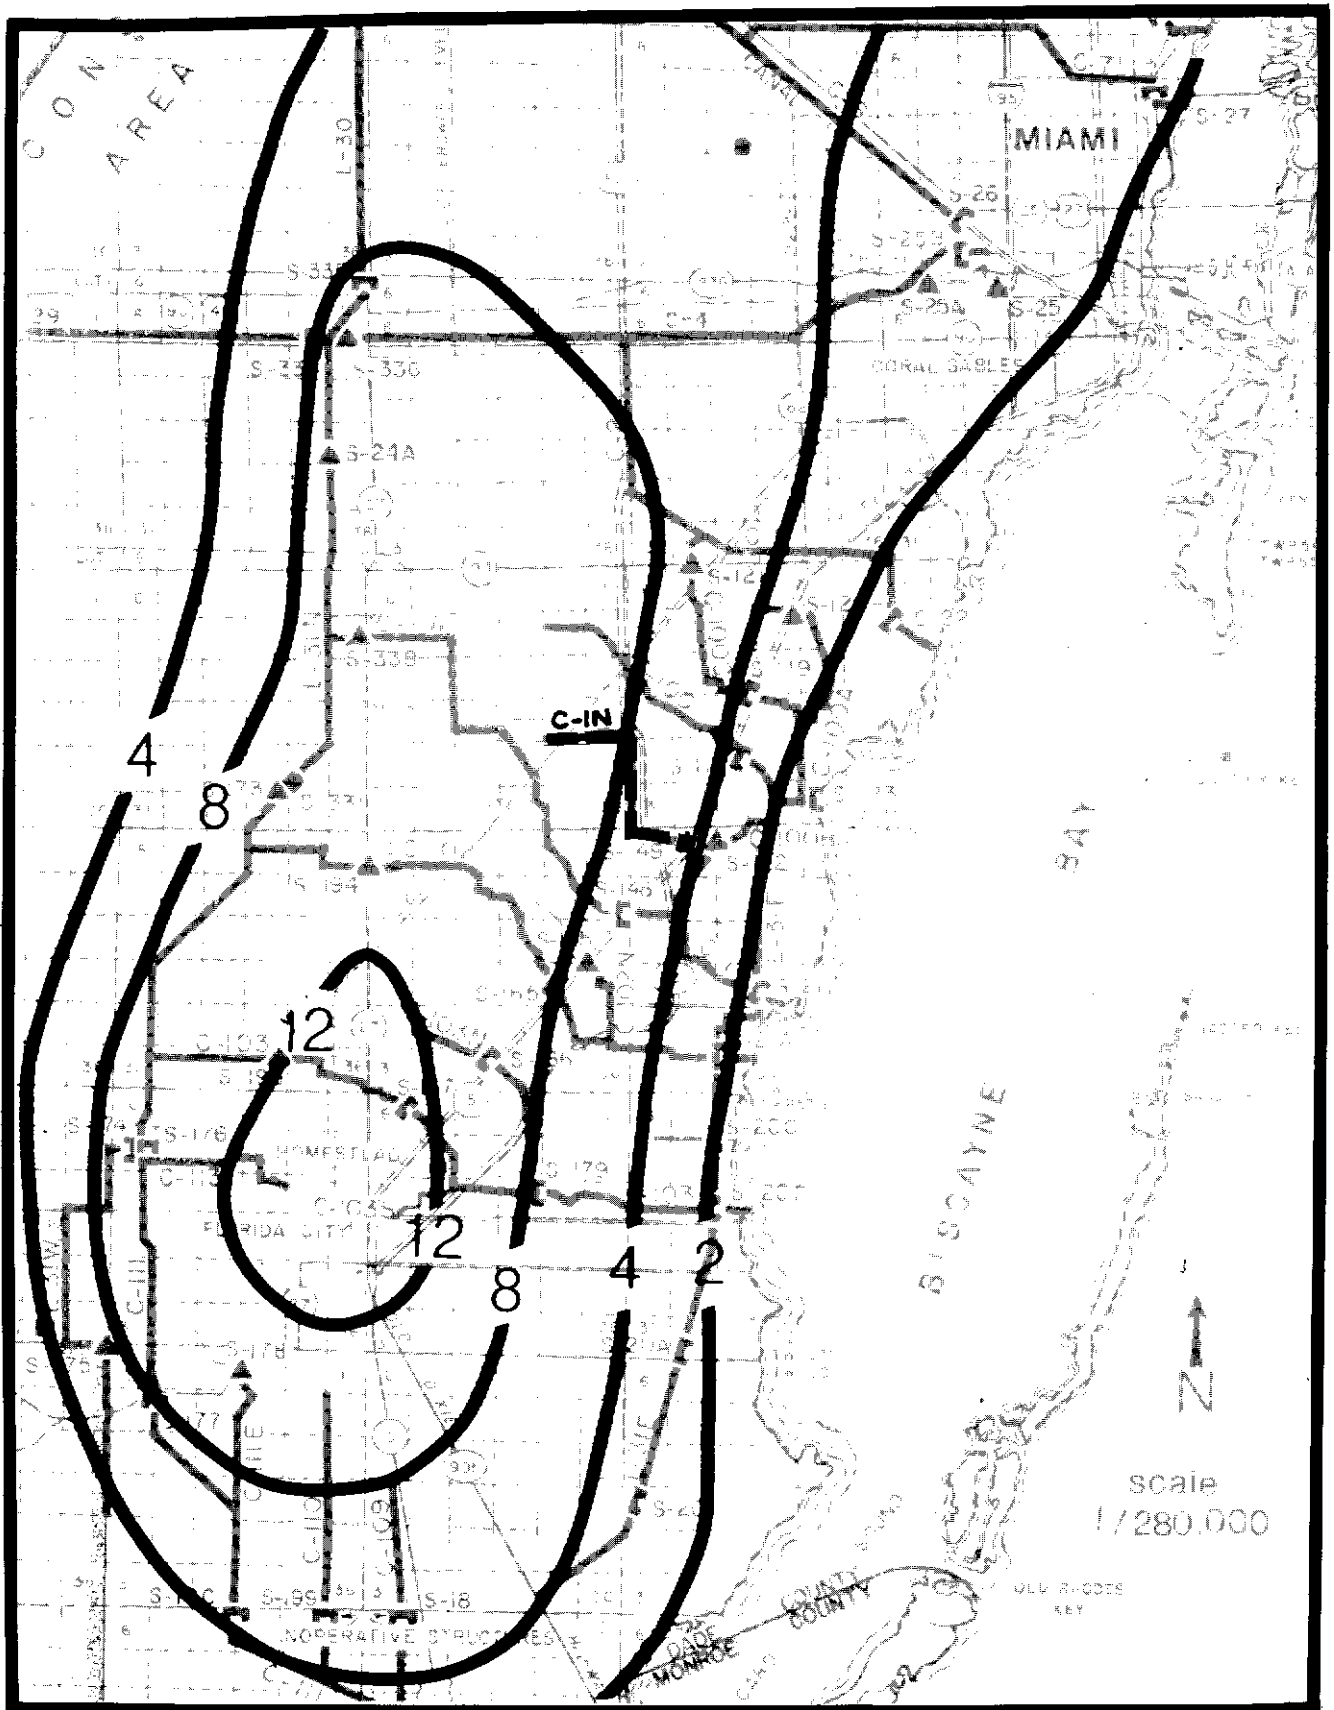
Figure 5. Contours of transmissivity for the Biscayne Aquifer in million gallons per day per foot (from U. S. Geological Survey, unpublished map).

The C-1N canal is entrenched into the upper part of the Biscayne aquifer, a highly permeable limestone extending throughout Dade County. Approximately the upper 40 feet of limestone comprising the Biscayne aquifer in this part of Dade County is the relatively soft Miami Oolite formation which has a more developed secondary permeability in the vertical direction than in the horizontal (Parker, et. al., 1955). Thus, the vertical flow component would tend to be more significant than the horizontal flow component given equal pressure gradients. Below 40 feet, the highly permeable Fort Thompson formation extends to depths of approximately 100 feet, completing the Biscayne aquifer. The areal distribution of the extremely high transmissivity (product of the permeability and aquifer thickness) of the Biscayne aquifer is shown on Figure 5.

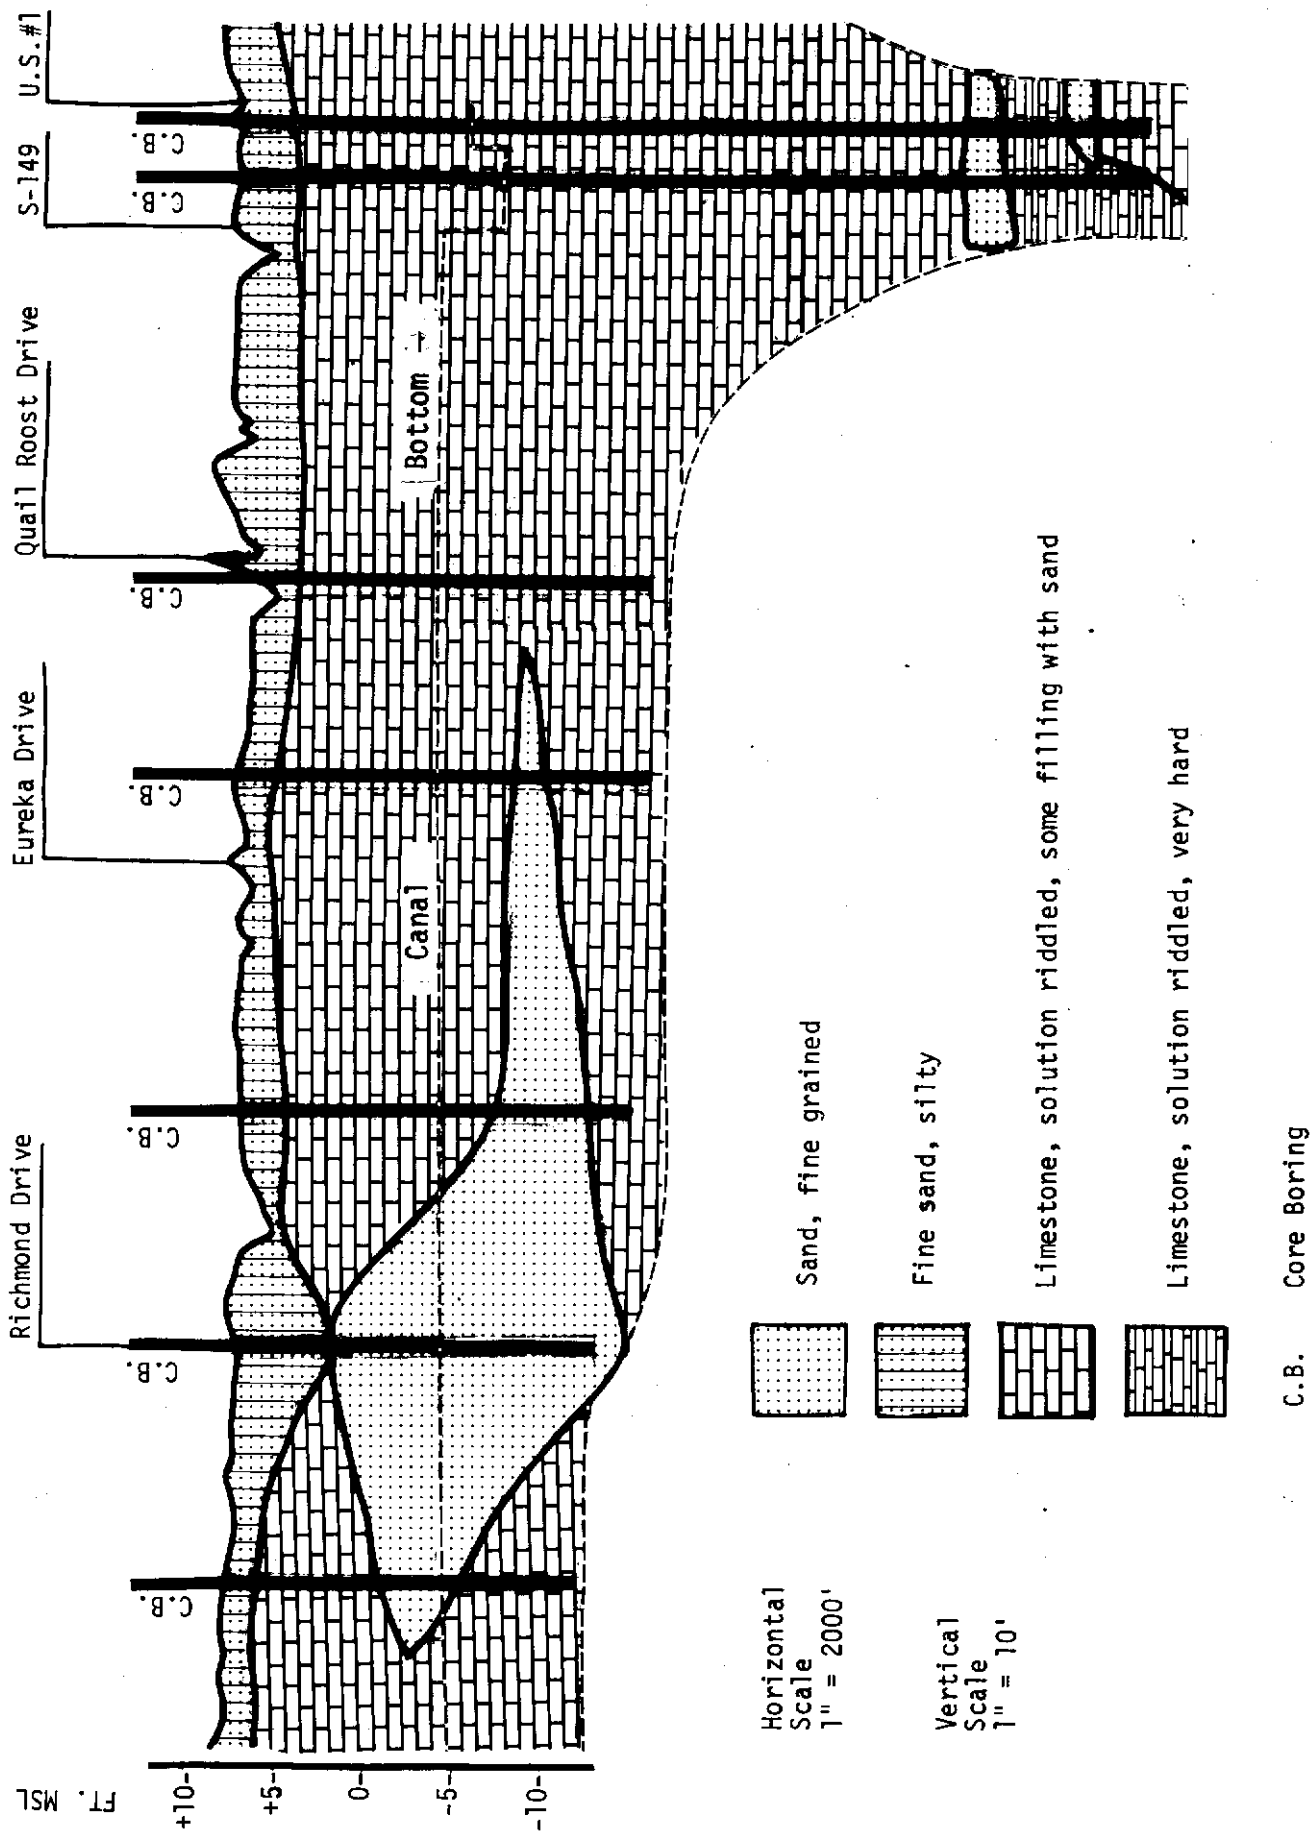
Figure 6. Geologic cross-section along the C-1N alignment showing the sand lense in the vicinity of Richmond Drive (Corps of Engineers, 1962).

of this structure (Corps of Engineers, 1962). Seventeen core borings were made along the canal alignment, seven of which are depicted on Figure 6. As determined by this investigation, a thin surficial layer of silty sand is underlain by a solution riddled limestone containing occasional lenses of fine grained sand to a depth of at least 45 feet. Although the solution holes in the limestone are partially filled with fine sand, the limestone is presumed to have a much higher hydraulic permeability than the fine sand. Consequently, the lenses of fine sand would behave as leaky barriers to the flow of water through the Biscayne aquifer.

At Richmond Drive, the thickest fine sand unit detected by borings along the canal forms the canal-aquifer boundary. It extends from land surface to a depth of 11 feet below the canal bottom. This sand extends 4,000 feet upstream of Richmond Drive and 7,800 feet downstream almost to Quail Roost Drive. The sand tapers in thickness to only 2.5 feet at Eureka Drive, where the top of the sand unit lies at least 4 feet below the canal bottom. Negligible sand is present at Quail Roost Drive and S-149. The considerable north-south dimension of the sand unit suggests that the east-west dimension may also be significant, having its expected maximum east-west dimension also near Richmond Drive. The importance of this sand lense, and its potential as a leaky barrier to the flow of water across the canal-aquifer interface, is discussed below.

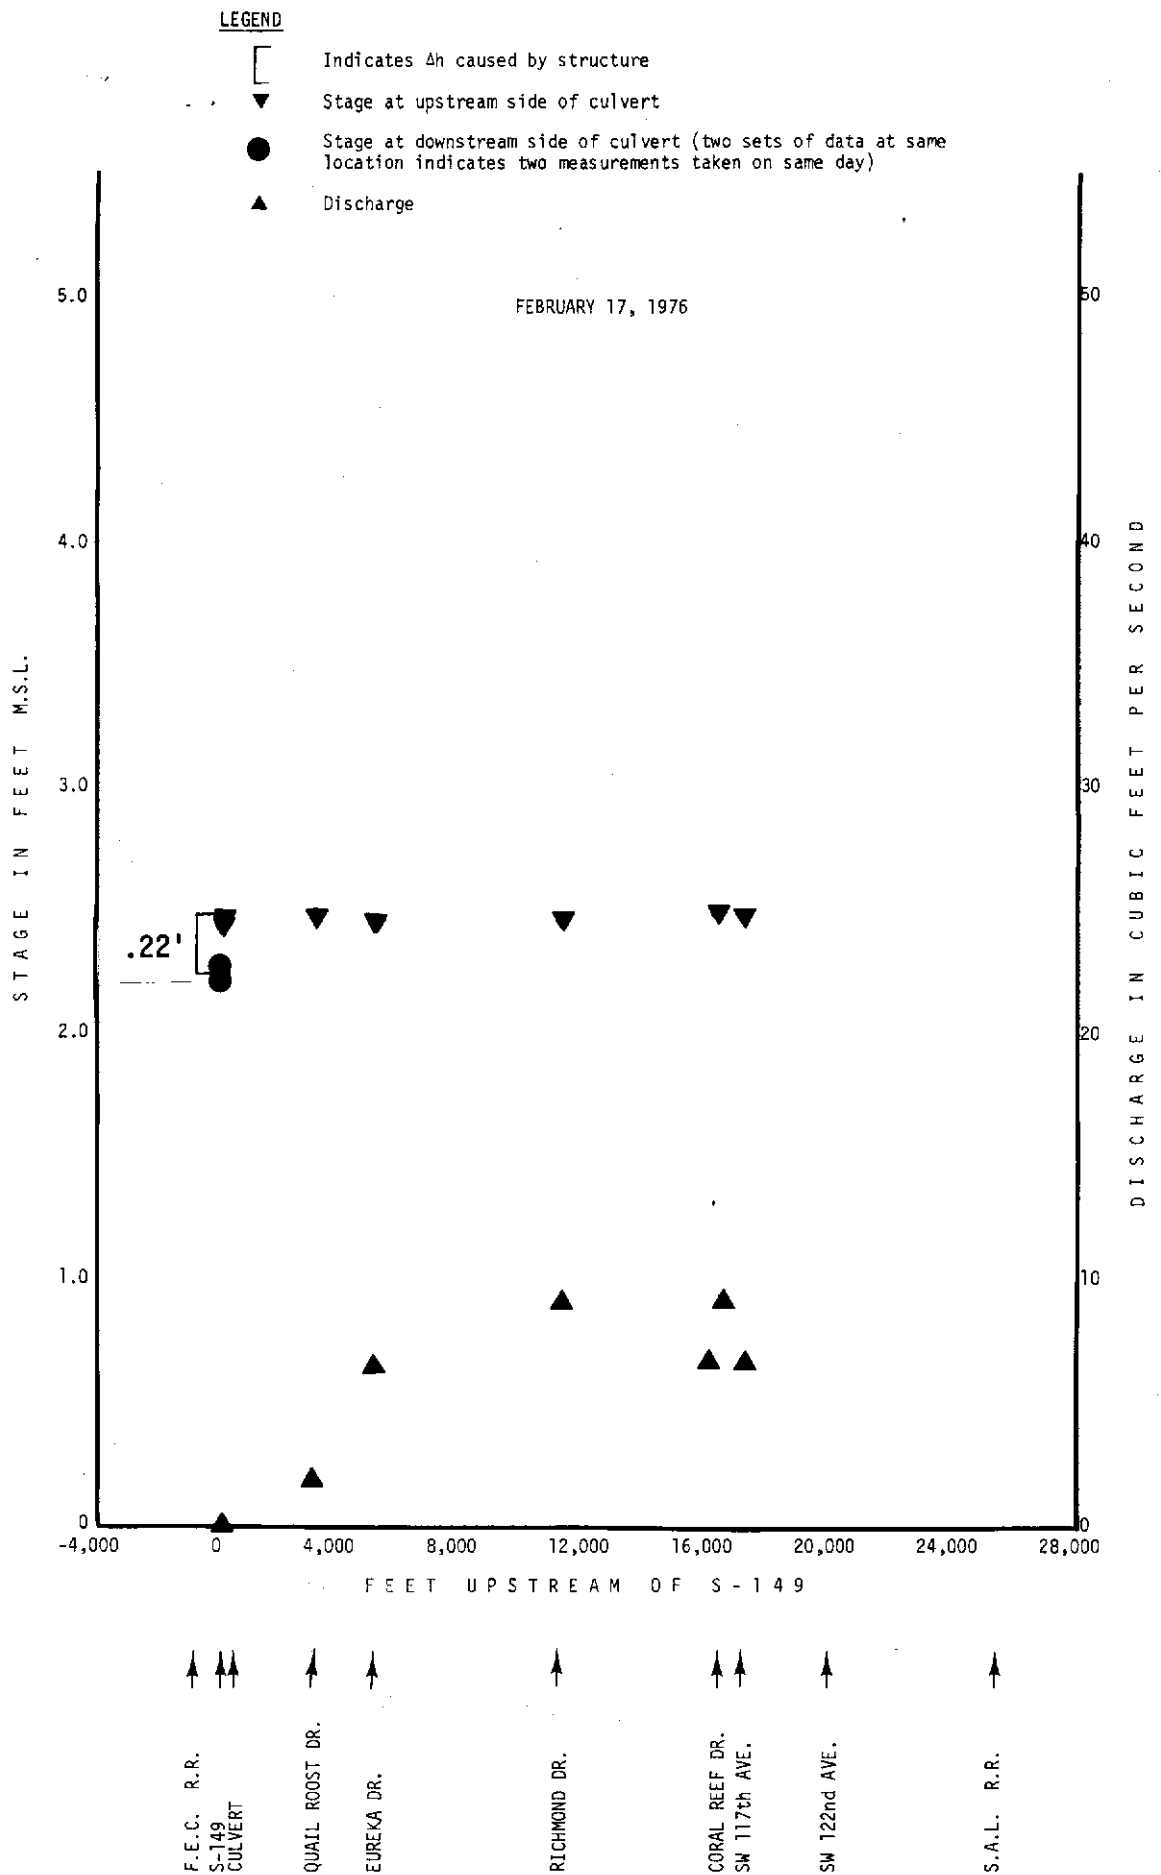
Figure 11. Stage and discharge profiles on February 17, 1976.

The limited data available indicate that when flow in the canal is unrestricted by the temporary structures (Figures 11 and 12), and canal stages are less than 3 feet msl, it (flow) reaches a maximum near Richmond Drive (data are not available on unrestricted flow profiles when stages

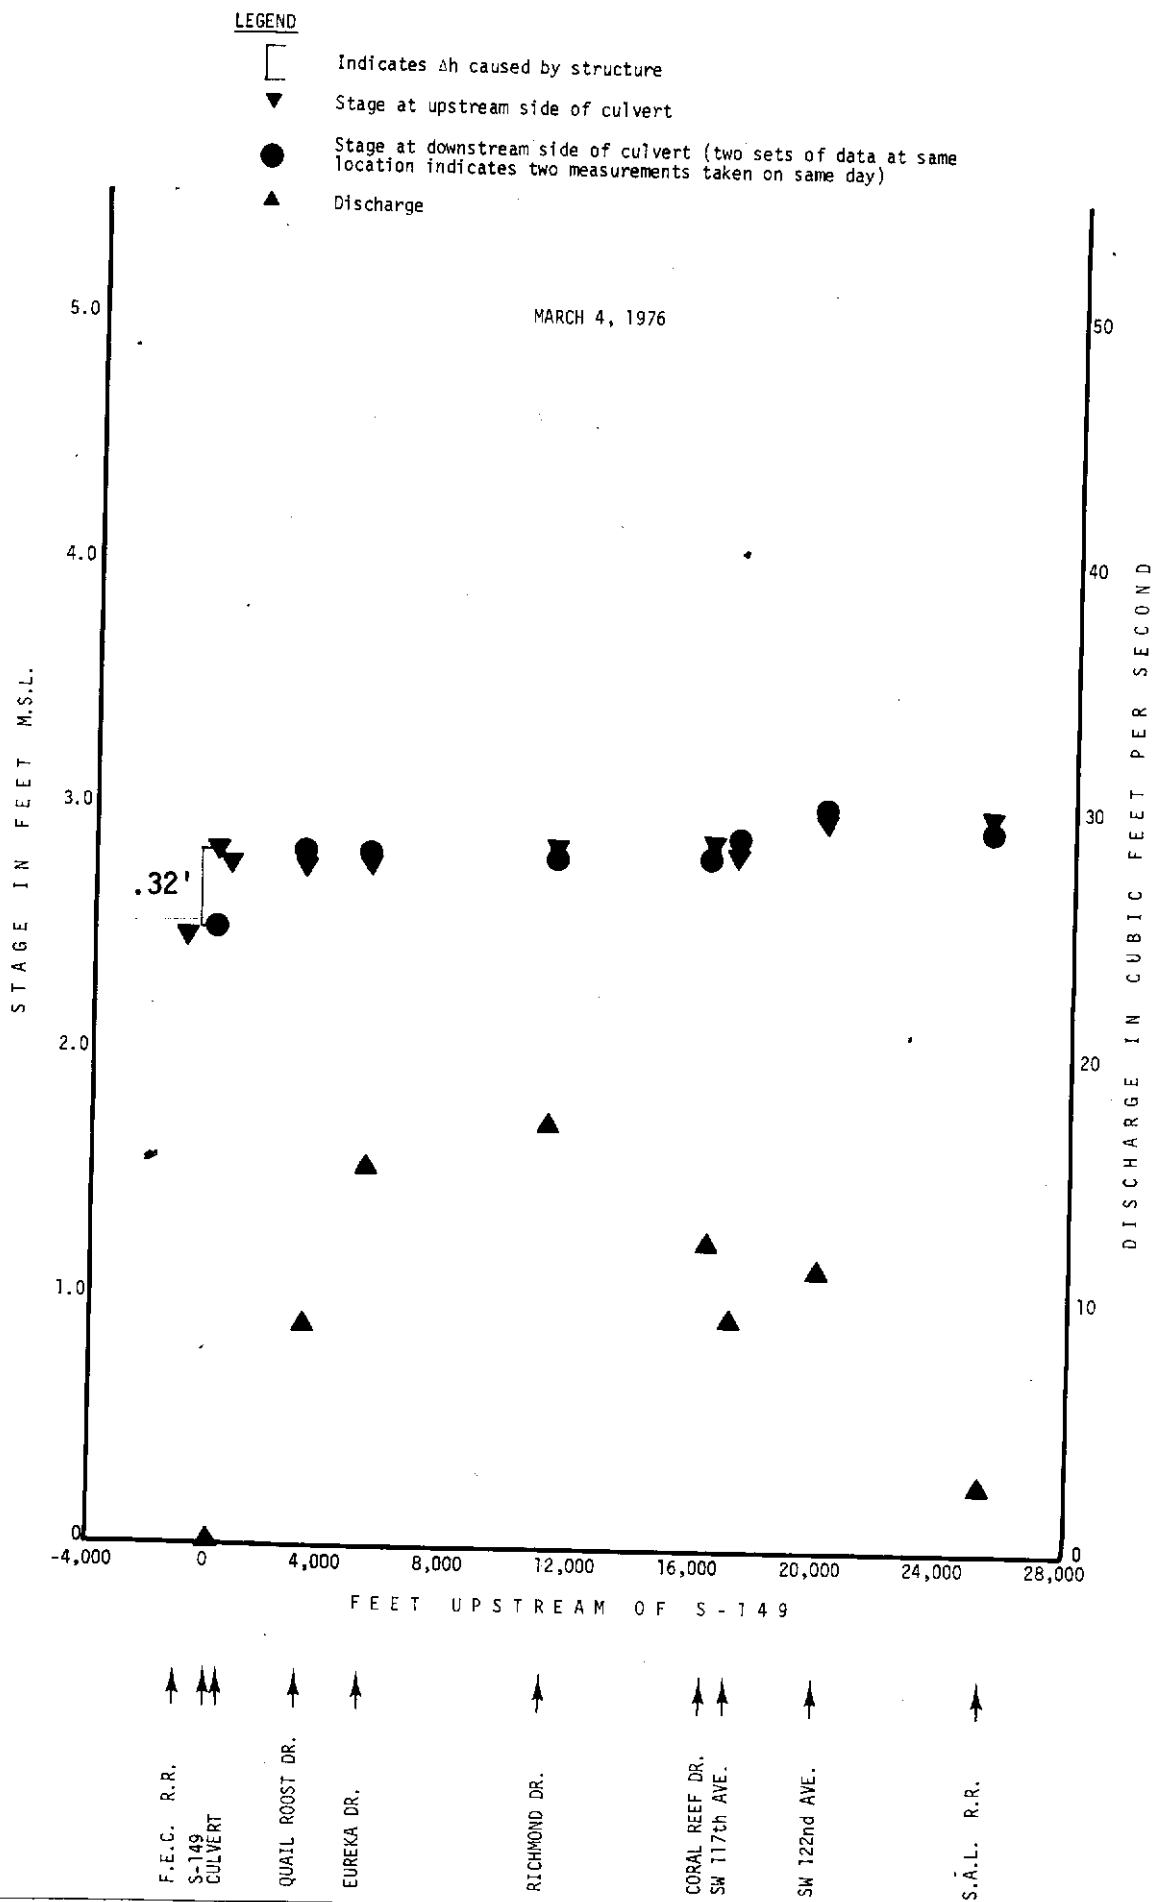
Figure 12. Stage and discharge profiles on March 4, 1976.

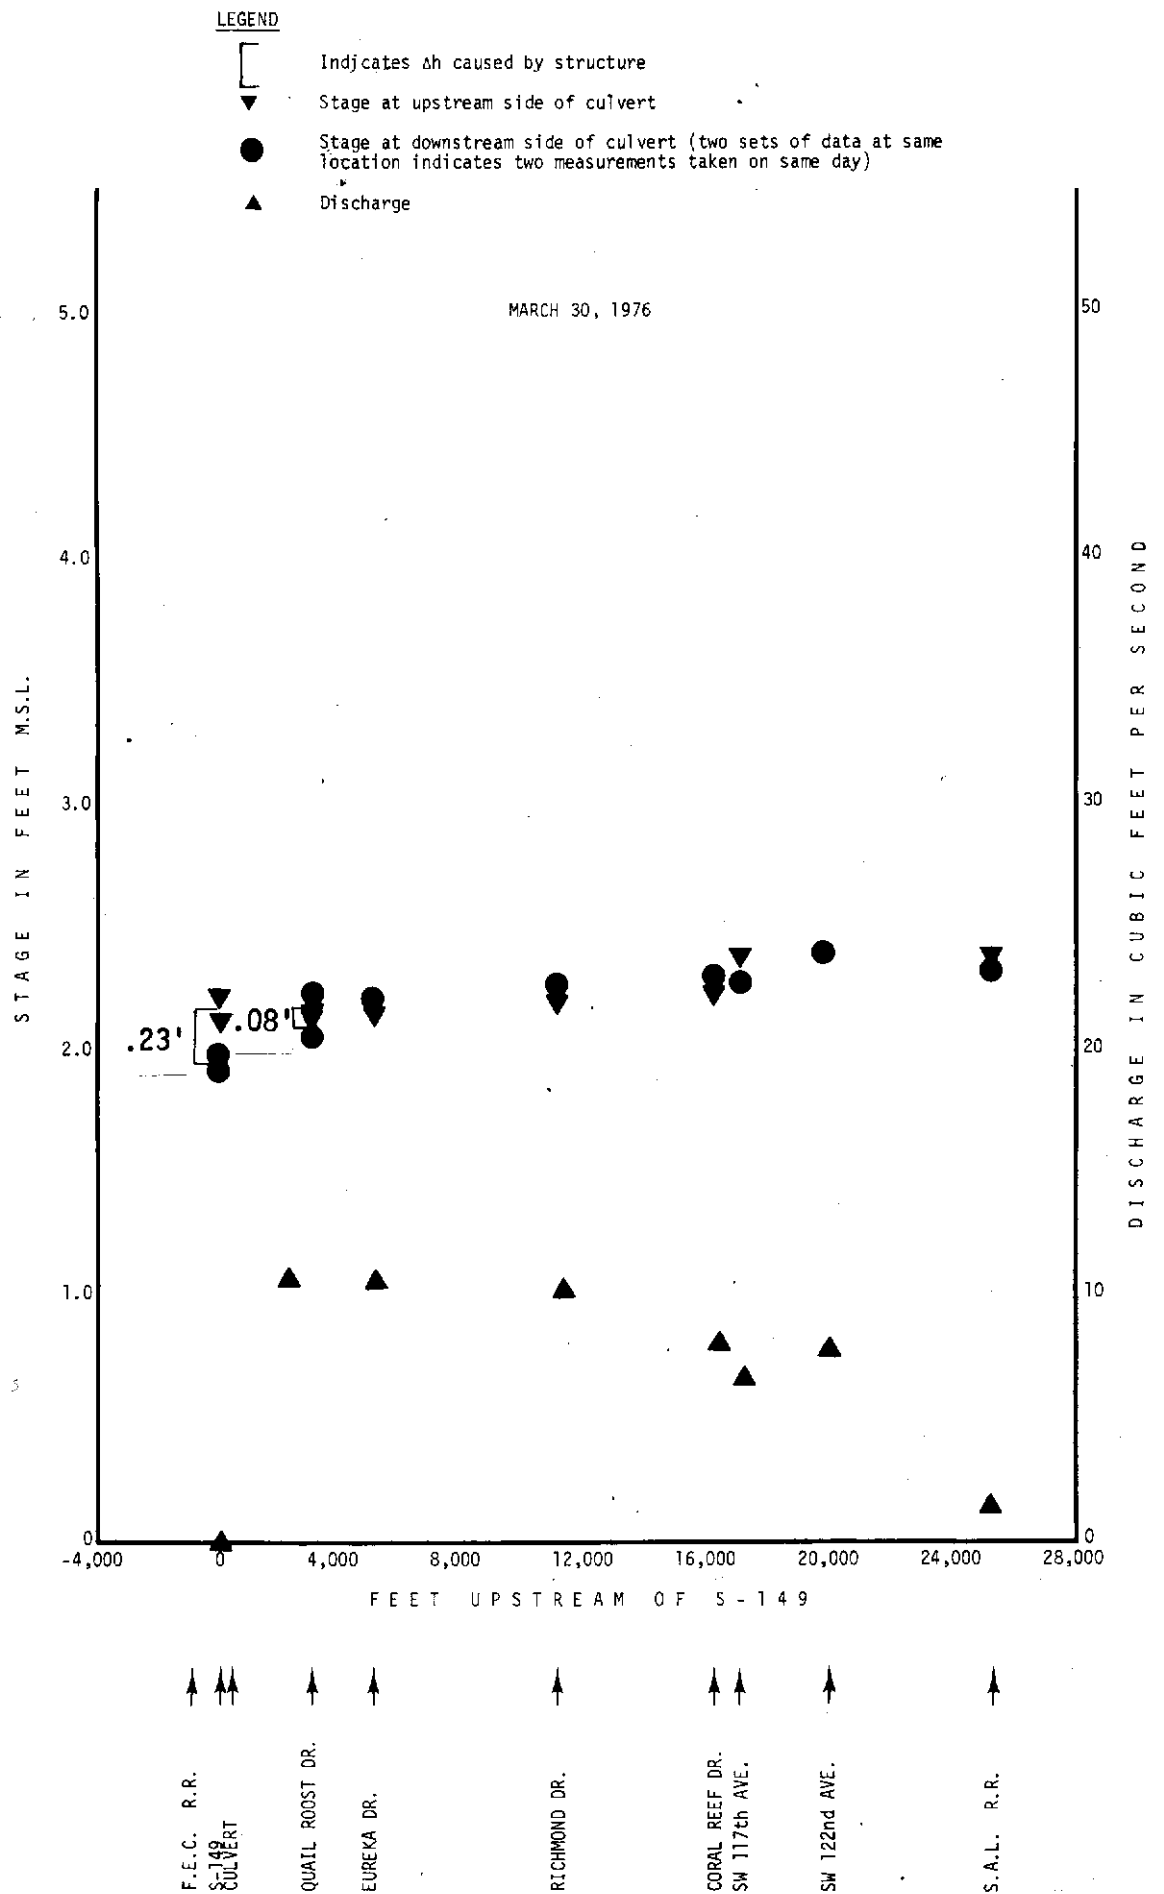
Figure 13. Stage and discharge profiles on March 30, 1976.

Generally, discharge measurements made when the temporary structures were operational indicate zero discharge at the structures. Two exceptions occurred at Quail Roost Drive on March 30 and August 23, 1976, when the

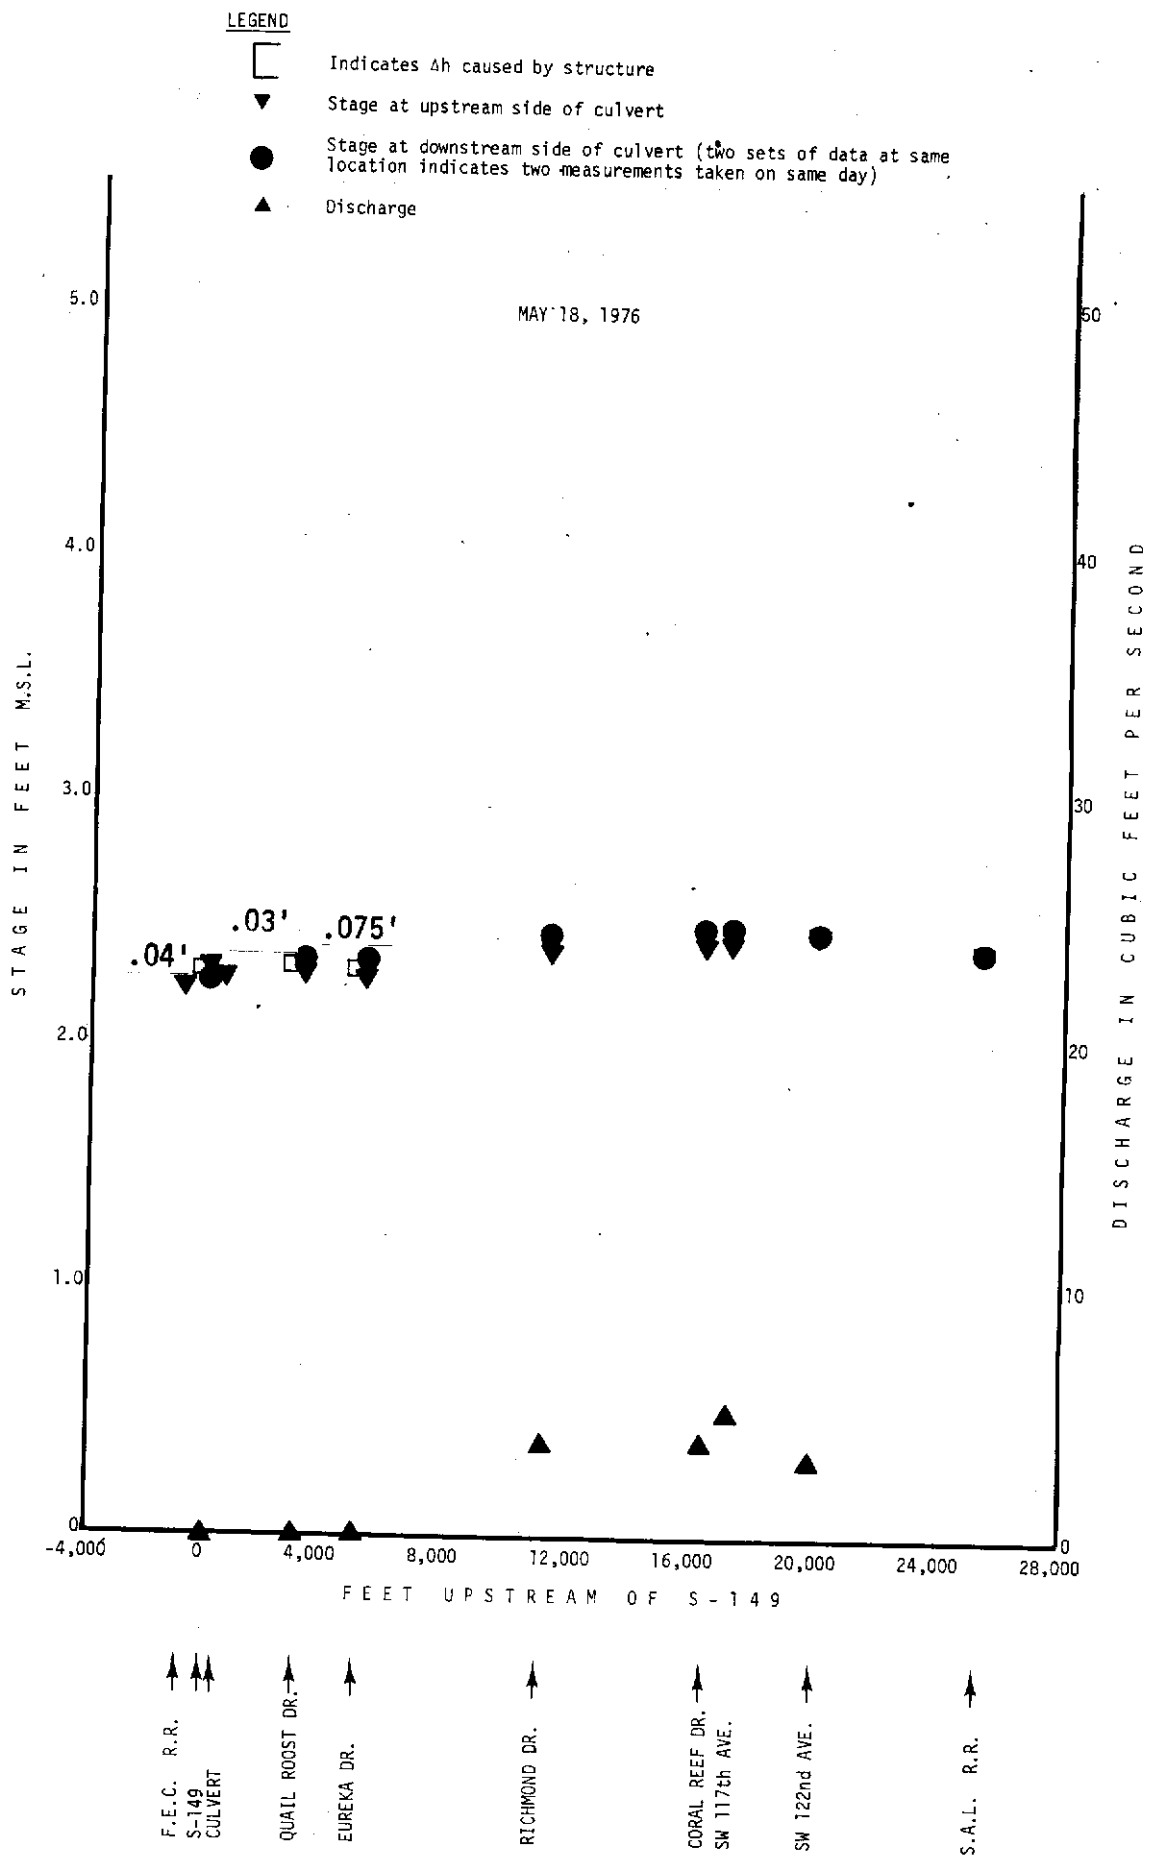
Figure 14. Stage and discharge profiles on May 18, 1976.
